# Non-Ablative Advanced Ceramic Antifouling Coating (AC<sup>2</sup>)

Pyro-augmented particulate spray (PAPS) of advanced ceramic antifouling coating (AC<sup>2</sup>).

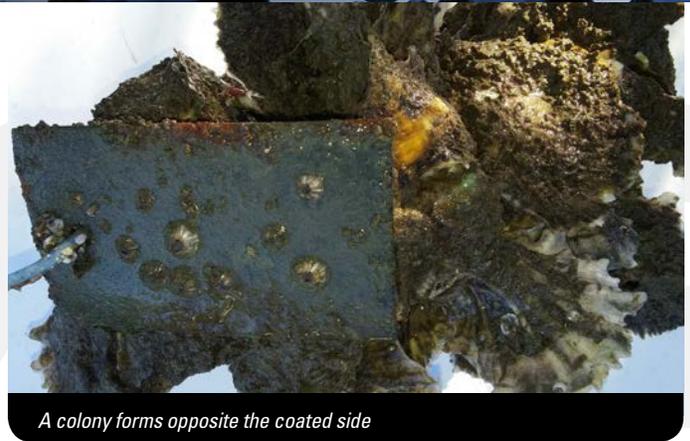
A colony forms opposite the coated side

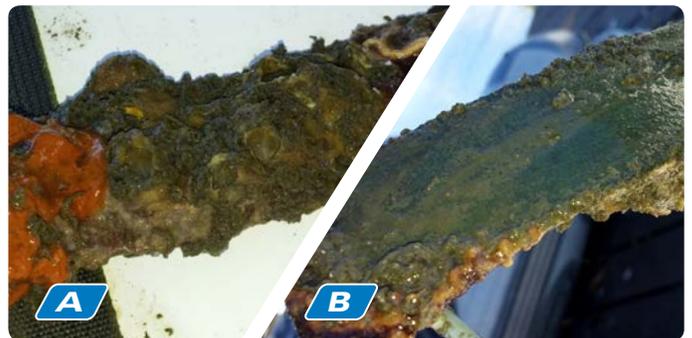
• A: Uncoated side

• B: Coated side after 18 months

Coupons of stainless steel and bronze were coated on one side with 10 mils of AC<sup>2</sup> via the PAPS process and subsequently sealed. These coupons were hung in a canal with relatively good tide flow on July 18, 2013. They were positioned such that they would be partially submerged or fully submerged depending on the tides. After two months in the water, the coupons demonstrated growth on the uncoated side however, the bronze had mild attack. The coated sides showed no signs of growth other than mild slime. After six months, the coated sides were performing phenomenally.

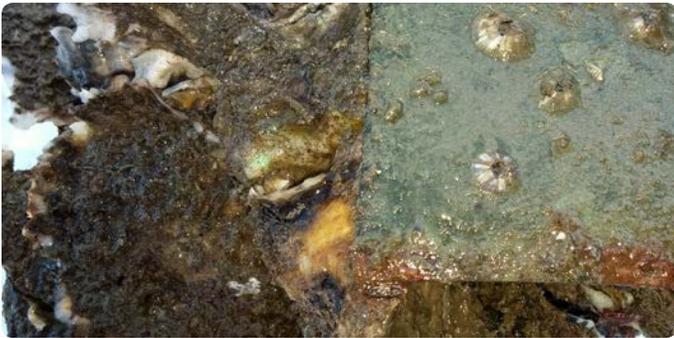
**A:** Massive attachment to uncoated side of coupon after 18 months submersion

**The photos below depict the coupons after 18 months of exposure demonstrating exceptional coating performance.**

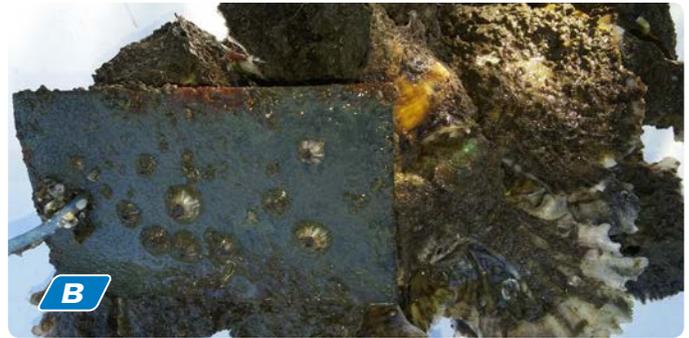
**B:** Stainless steel coupon coated side showed mild barnacle attachment after 18 months

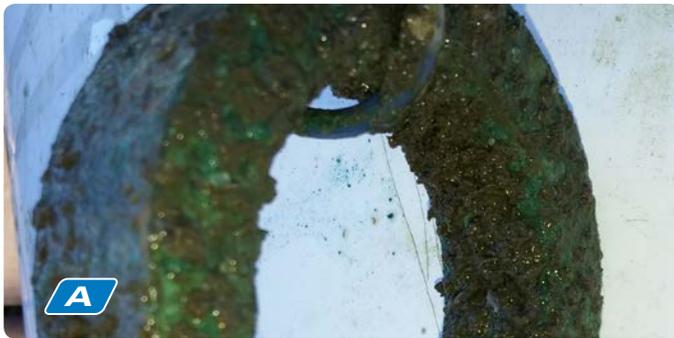
**A:** Uncoated bronze showing less, but still aggressive growth when unprotected with our coating

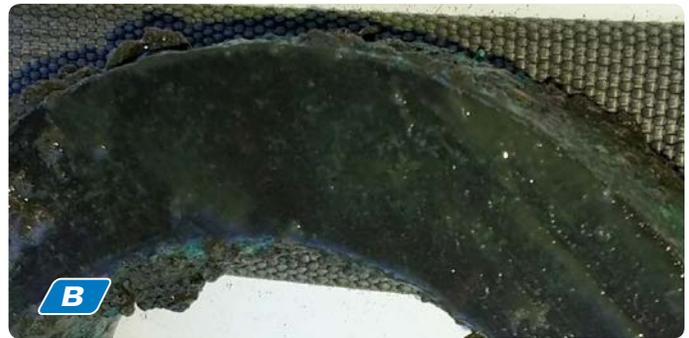
**B:** Bronze ring coated one face (blackened area) showing resistance to growth
